**Flood Control Project Maintenance  
Levee Inspections****2015 Channel Summary Report****Overall Unit and Item Ratings****Fairfield Suisun Sewer District**

**Flood Control Project Maintenance****Unit Cover Sheet****2015 Channel Inspection Results****Fairfield Suisun Sewer District**

**Levee Inspection Report By Mile - Channel 2015**

**Fairfield Suisun Sewer District**

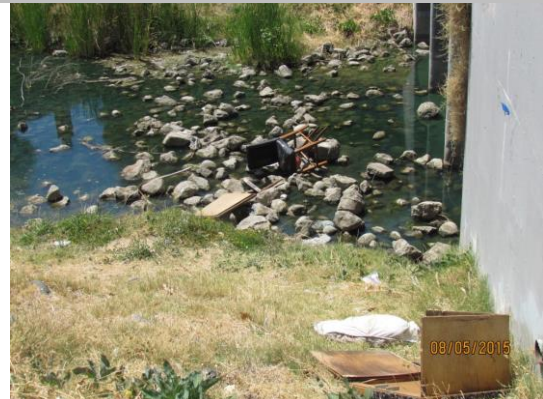
Photo 1 of 1 : CH\_2015\_NA0035\_15\_30\_20150817\_00052.jpg

Suggest removal of debris from the channel. Summer 2015.

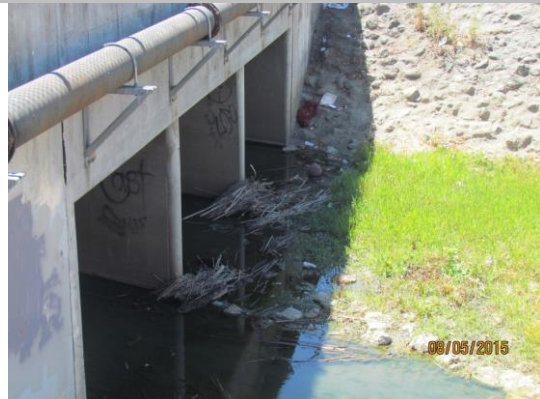
Photo 1 of 1 : CH\_2015\_NA0035\_15\_35\_20150817\_00054.jpg

Debris slowly building up. Suggest monitoring and cleaning buildup. Summer 2015.

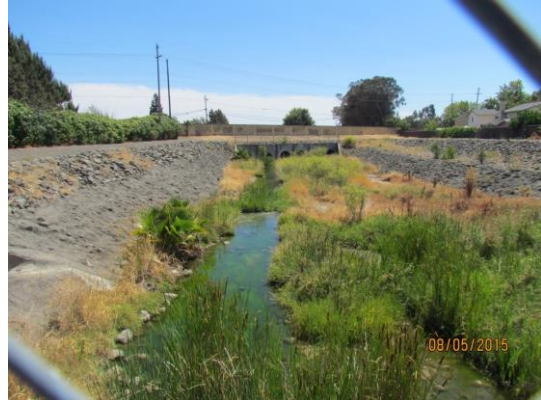
Photo 1 of 2 : CH\_2015\_NA0035\_15\_46\_20150817\_00057.jpg

Rating **	A	Issue No.	46	GPS Lat/Long
Issue Type +	Ma	Location *		38.259230 °
Category	Rivers, Channels & Designated Flood			-122.017714 °
Item	Vegetation & Obstructions			
DWR ID	DWR_NA0035_15_c _ 2012_46			
Action/Comments				
Inspector Comments: This area is the same as upstream Railroad Avenue. I recommend the removal of the baby palm trees.

Looking downstream from Matthews Rd. Pipe goes under the railroad. Summer 2015.

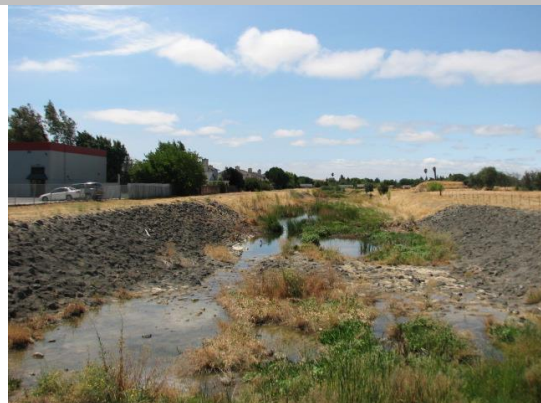
Photo 2 of 2 : CH\_2015\_NA0035\_15\_56\_20150612\_00031.jpg

Looking downstream from Railroad Ave. Woody vegetation has been removed. Summer 2014

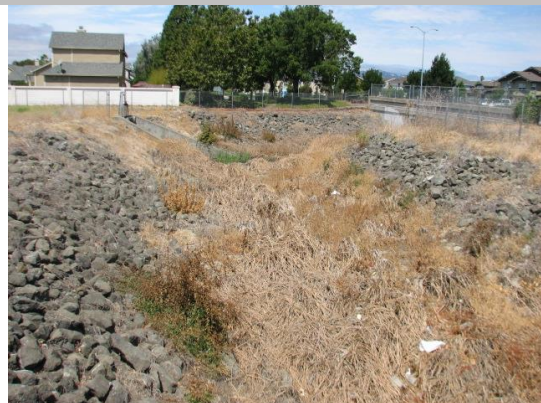
Photo 2 of 2 : CH\_2015\_NA0035\_15\_61\_20150612\_00033.jpg

Looking upstream the woody vegetation has been removed from Sunset Ave. Summer 2014

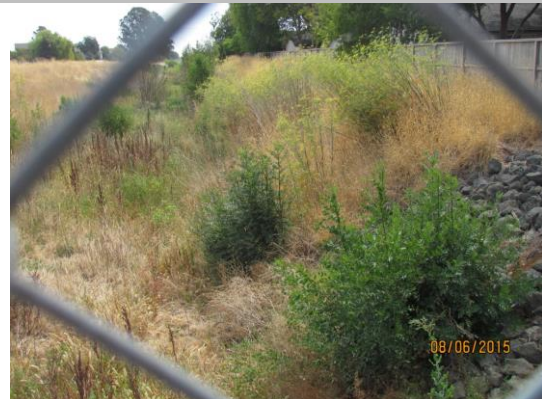
Photo 1 of 3 : CH\_2015\_NA0035\_15\_66\_20150817\_00064.jpg

Looking downstream from Sunset Ave. Suggest removal of woody vegetation. Summer 2015.

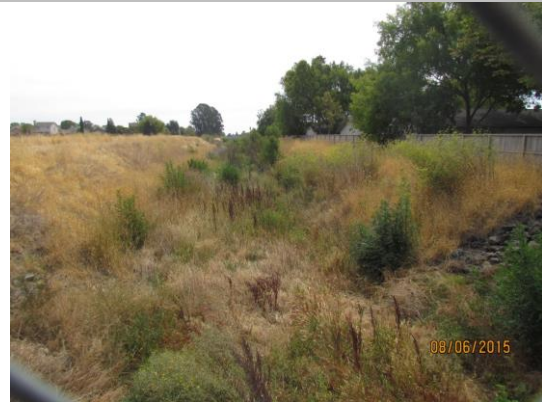
Photo 2 of 3 : CH\_2015\_NA0035\_15\_66\_20150817\_00063.jpg

Looking downstream from Sunset Ave. Some woody vegetation has been removed. Summer 2015.

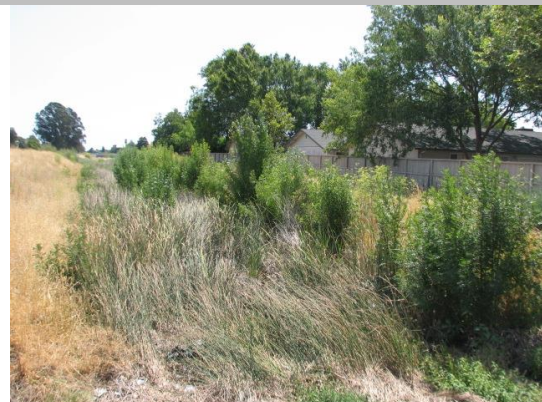
Photo 3 of 3 : CH\_2015\_NA0035\_15\_66\_20150612\_00035.jpg

Looking downstream from Sunset Ave. Woody vegetation needs to be removed blocks flow. Summer 2014

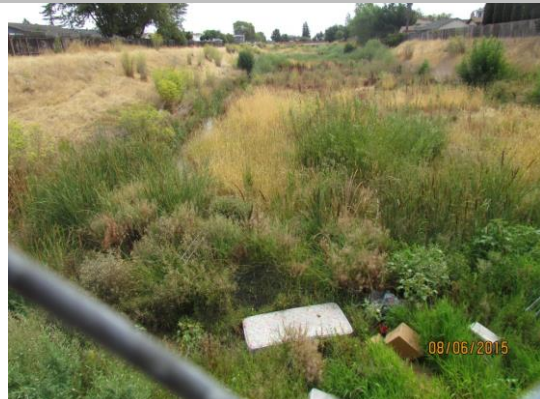
Photo 1 of 2 : CH\_2015\_NA0035\_15\_90\_20150817\_00073.jpg

Perspective view of the debris looking downstream from Worley Rd.  
Summer 2015.

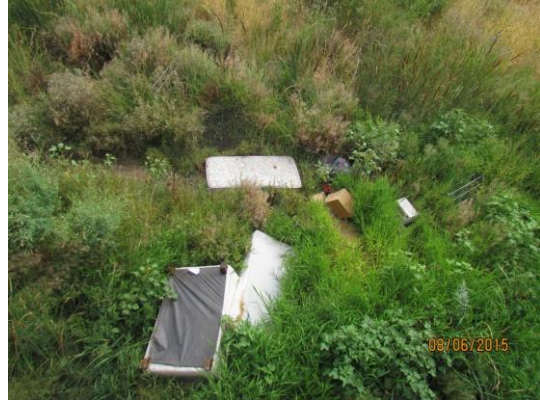
Photo 2 of 2 : CH\_2015\_NA0035\_15\_90\_20150817\_00072.jpg

Suggest removal of debris on the downstream side of the channel.  
Summer 2015.

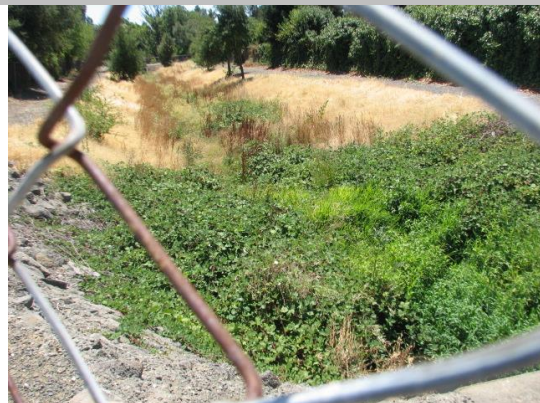
Photo 2 of 3 : CH\_2015\_NA0035\_17\_6\_20150612\_00009.jpg

Looking downstream from Astoria Dr. Blackberries need to be removed as they will impeded the flow. Summer 2014

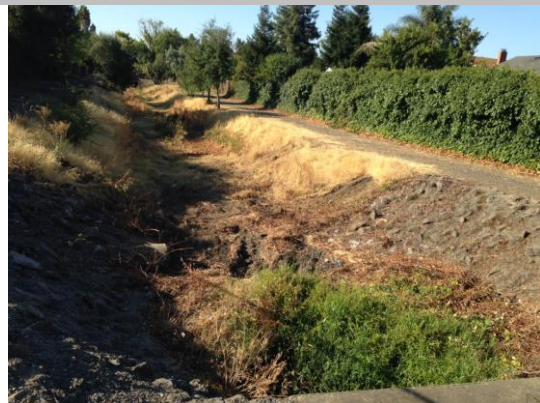
Photo 3 of 3 : CH\_2015\_NA0035\_17\_6\_20150612\_00008.jpg

Corrected view of blackberries from Astoria Drive. Aug. 27, 2014

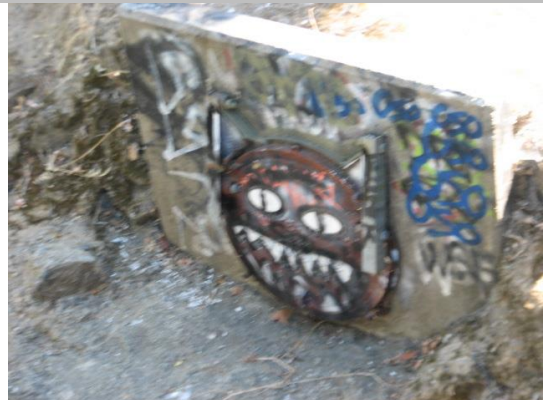
Photo 1 of 2 : CH\_2015\_NA0035\_17\_24\_20150612\_00016.jpg

Inspector Comments: Flap gate has been replaced.

Flap gate has been replace and tagged (Summer 2013)

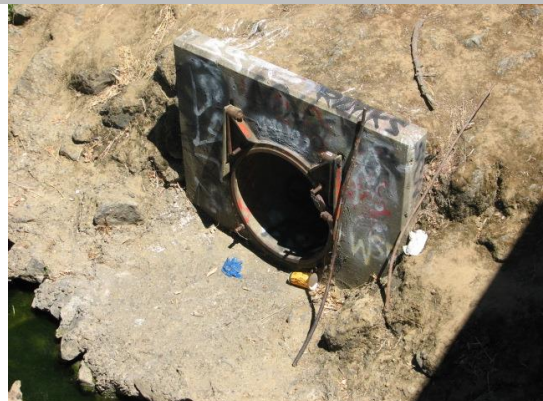
Photo 2 of 2 : CH\_2015\_NA0035\_17\_24\_20150612\_00017.jpg

The flap gate has not been replaced. Should have a new one installed. (2012)

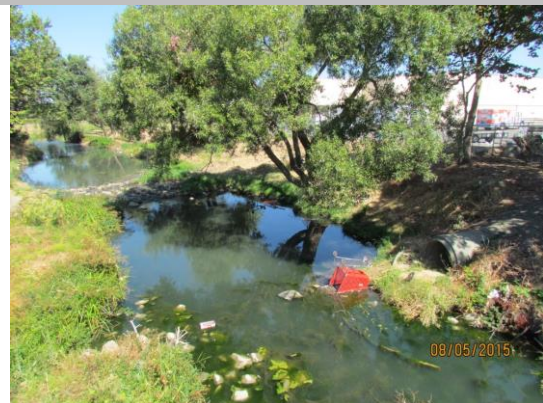
Photo 1 of 3 : CH\_2015\_NA0035\_17\_41\_20150817\_00063.jpg

Looking upstream from Woolner Ave. Suggest removing cart from the channel. Summer 2015.

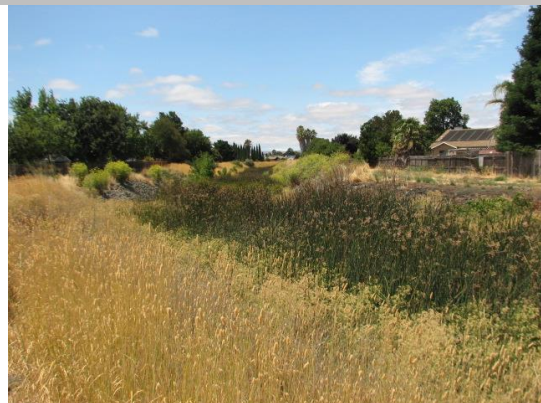
Photo 2 of 2 : CH\_2015\_NA0035\_14\_6\_20150612\_00007.jpg

Looking downstream at Bella Vista Ave. Woody vegetation is getting larger; need to remove. Summer 2014

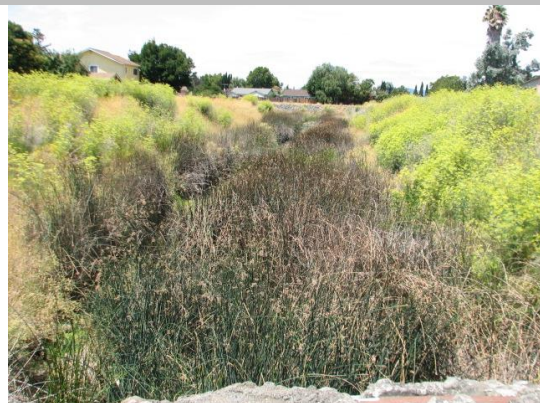
Photo 3 of 3 : CH\_2015\_NA0035\_14\_16\_20150612\_00012.jpg

Looking downstream from Emperor Dr. Need to clear vegetation 50-100 feet from roadway. Summer 2014

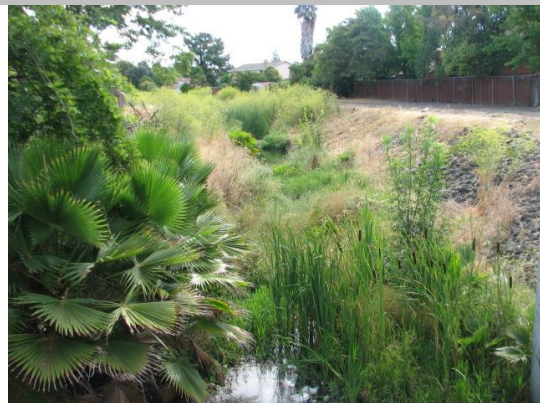
Photo 2 of 3 : CH\_2015\_NA0035\_16\_6\_20150612\_00003.jpg

Looking downstream from N. Texas St. Remove palm tree and heavy vegetation. Summer 2014

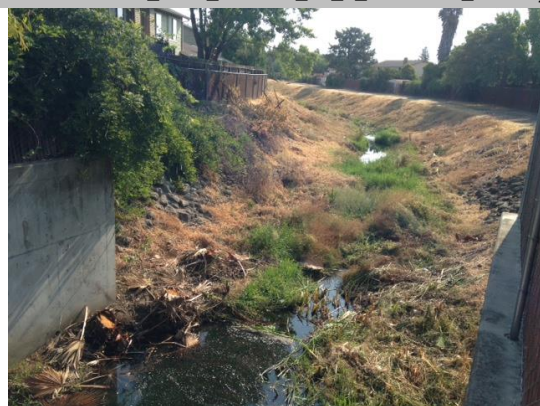
Photo 3 of 3 : CH\_2015\_NA0035\_16\_6\_20150612\_00002.jpg

Corrected issue at N. Texas St. 8-27-2014
